Intra-prosthetic dislocation of dual mobility hip prosthesis: an original and unusual complication

Radiology Case. 2019 May; 13(5):15-23 :: DOI: 10.3941/jrcr.v13i5.3465

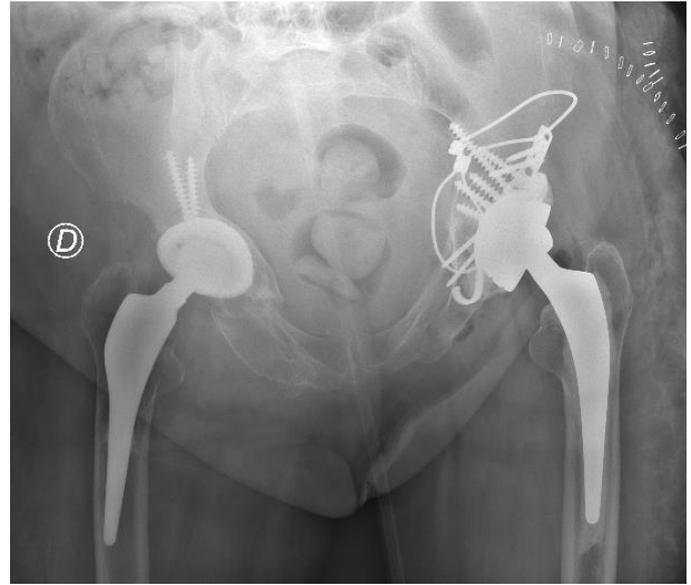
Figure 3: 78-year-old female showing revision surgery on left hip prosthesis.

Technique: plain anteroposterior pelvis radiograph.

Findings: left revision surgery with osteosynthesis of the acetabulum with cerclage, plate, screws and Ganz revision ring, with cemented hip stem and dual mobility cup. Right hip prosthesis implant properly positioned.

A 78-year-old female with a left total hip arthroplasty (cemented stem and press-fit cup), performed 6 years earlier, was admitted to our emergency room following a fall on her left hip. The radio-clinical evaluation revealed a transverse peri-prosthetic fracture of the left acetabulum, for which open reduction and osteosynthesis was performed through a posterior approach (Figure 1,2). During the surgery, the acetabular implant was revised by the implantation of a Ganz reinforcement ring fixed by 2 screws and a strapping, as well as a double mobility cup (head 28 mm) cemented in this ring (Figure 3,4).

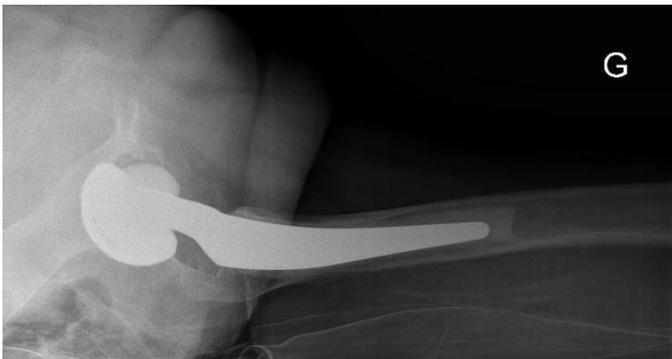
Figure 2: 78-year-old female showing a transverse peri-prosthetic fracture of the left acetabulum .

Technique: plain axial hip radiograph.

Findings: a transverse peri-prosthetic fracture of the left acetabulum. The cup of the left hip prosthesis implant is pushed and turned in the acetabulum.

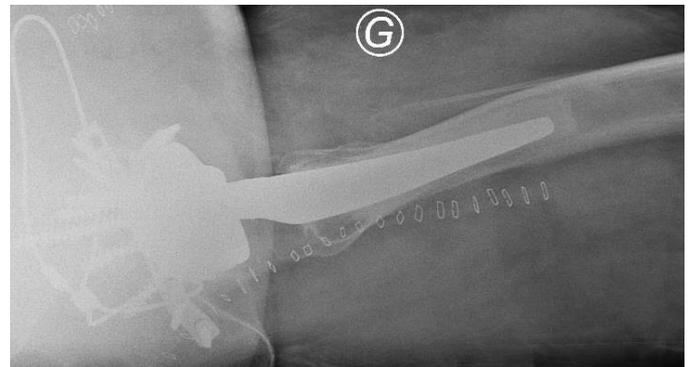
Figure 4: 78-year-old female showing revision surgery on left hip prosthesis.

Technique: plain axial hip radiograph.

Findings: left revision surgery with osteosynthesis of the acetabulum with cerclage, plate, screws and Ganz revision ring, with cemented hip stem and dual mobility cup.

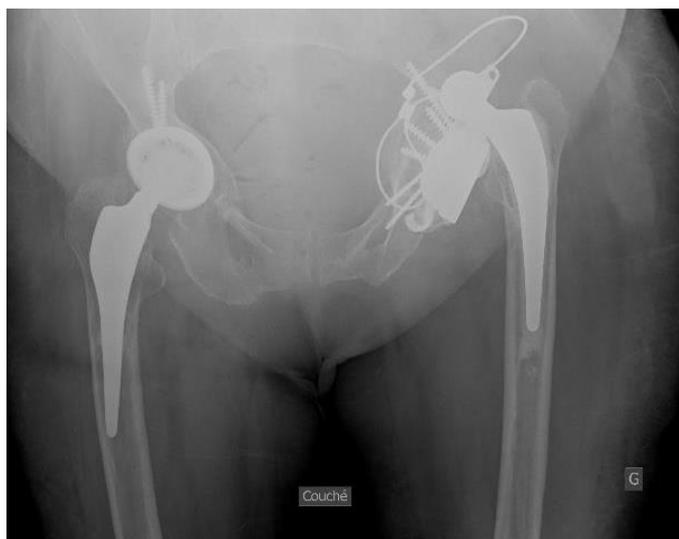
Figure 5: 78-year-old female showing dislocation of the left hip prosthesis.

Technique: plain anteroposterior pelvis radiograph.

Findings: a dislocation of the left hip prosthesis with dual mobility cup. Left revision surgery with osteosynthesis of the acetabulum with cerclage, plate, screws, Ganz revision ring with dual mobility cup, and cemented hip stem. Right hip prosthesis implant properly positioned.

The patient presented a first dislocation of her left hip six days after surgery (Figure 5,6), followed by another episode suggesting a new dislocation 48 hours later. After each closed reduction attempt, the hip appeared clinically unstable. Standard AP x-rays after reduction were nevertheless considered satisfactory with a head appearing centered in the cup (Figure 7). A pelvis CT was thereby performed to investigate the clinical sensation of instability. The CT showed a foreign body corresponding to the mobile polyethylene insert in the gluteal muscle mass and the metal head was in direct contact with the metal cup (Figure 8, 9, 10), which corresponds to an intra-prosthetic dislocation (IPD). A

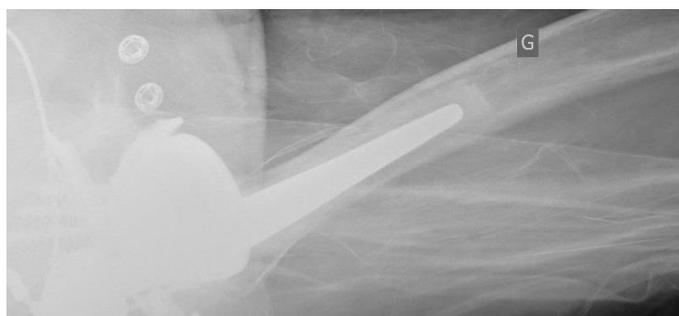
Figure 6: 78-year-old female showing dislocation of the left hip prosthesis.

Technique: plain axial hip radiograph.

Findings: a dislocation of the left hip prosthesis with dual mobility cup. Hip prosthesis is posteriorly positioned. Left revision surgery with osteosynthesis of the acetabulum with cerclage, plate, screws, Ganz revision ring with dual mobility cup, and cemented hip stem.

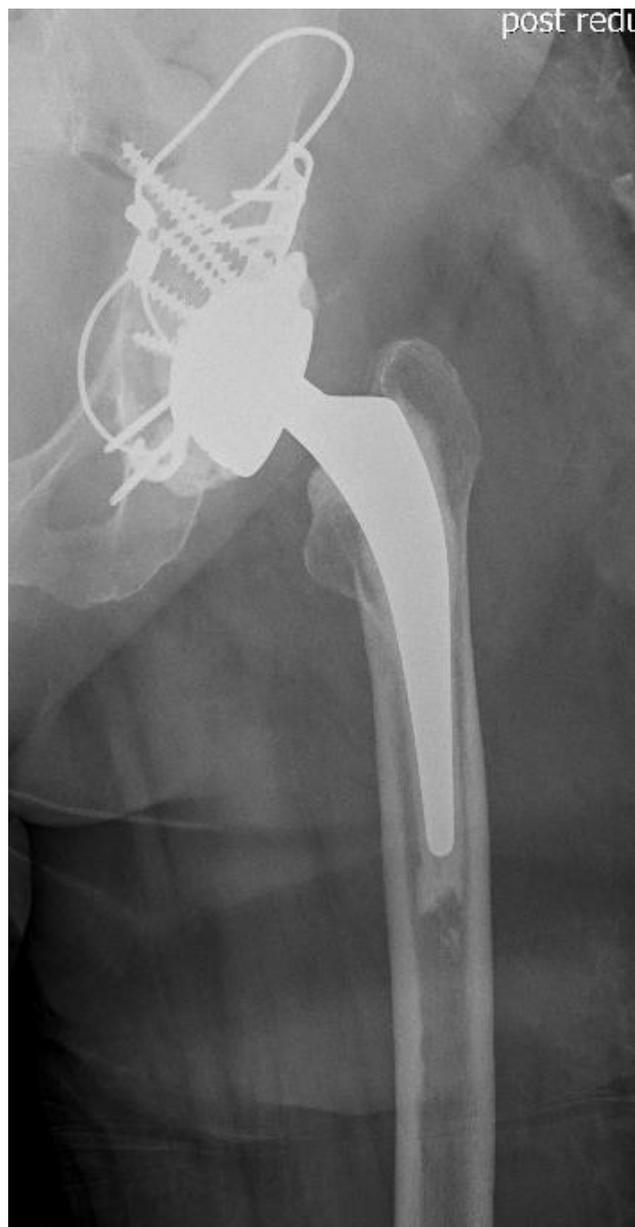
Figure 7: 78-year-old female after closed reduction on left hip prosthesis.

Technique: plain anteroposterior hip radiograph.

Findings: left hip prosthesis that seems in good place after closed reduction.

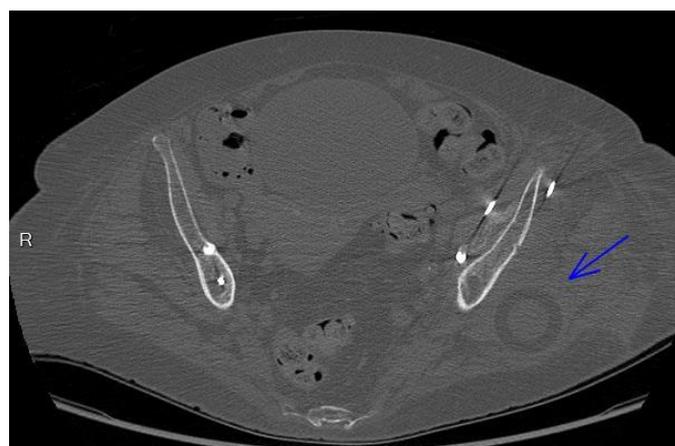
Figure 8 (right): 78-year-old female with intra-prosthetic dislocation.

Findings: this picture shows a foreign body which is the mobile polyethylene insert (blue arrow) in the gluteal muscle mass corresponding to posteriorly dislocated prosthetic implant on axial view

Technique: Computed Tomography on axial view (Toshiba Aquilion 64) without contrast, 150 mA, 120 kV, 2.00 mm slice thickness, Matrix 512*512, FOV 300, artefact reduction

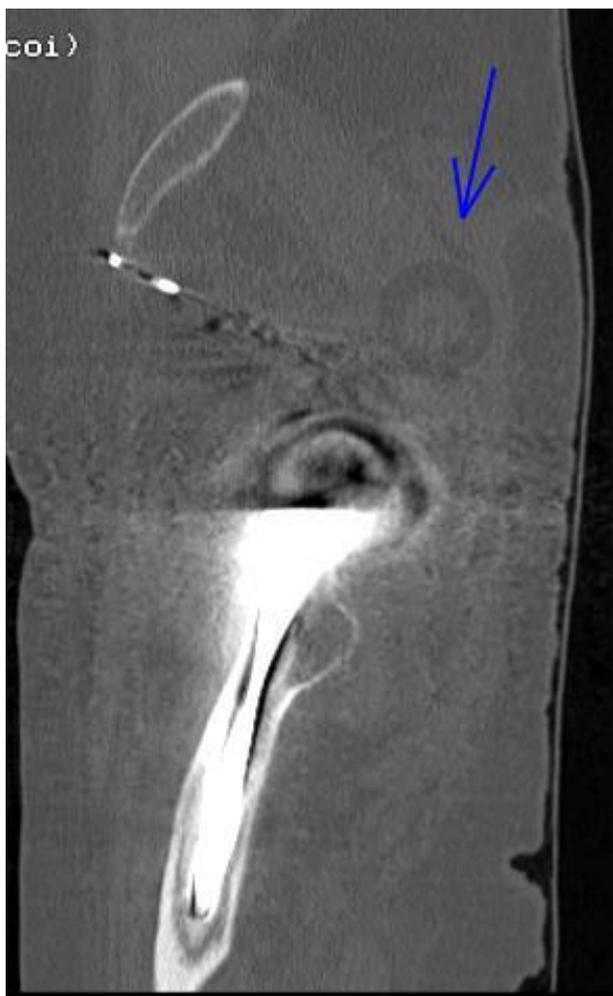
Figure 10: 78-year-old female with intra-prosthetic dislocation.

Findings: this picture shows a foreign body which is the mobile polyethylene insert (blue arrow) in the gluteal muscle mass corresponding to posteriorly dislocated prosthetic implant on coronal view

Technique: Computed Tomography on coronal view (Toshiba Aquilion 64) without contrast, 150 mA, 120 kV, 2.00 mm slice thickness, Matrix 512*512, FOV 300, artefact reduction

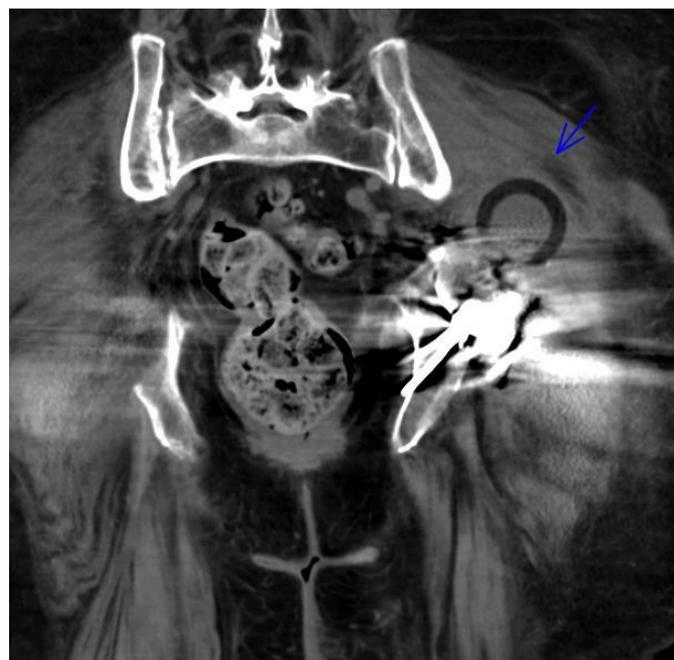
Figure 9: 78-year-old female with intra-prosthetic dislocation. Findings: this picture shows a foreign body which is the mobile polyethylene insert (blue arrow) in the gluteal muscle mass corresponding to posteriorly dislocated prosthetic implant on sagittal view

Technique: Computed Tomography on sagittal view (Toshiba Aquilion 64) without contrast, 150 mA, 120 kV, 2.00 mm slice thickness, Matrix 512*512, FOV 300, artefact reduction

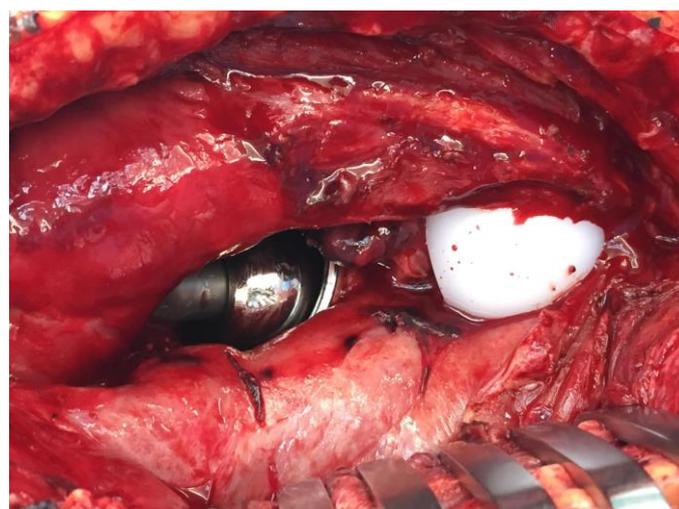
Figure 11: 78-year-old female during revision surgery for intra-prosthetic dislocation.

Findings: this picture shows an intra-prosthetic dislocation. The white part (on the right) is the polyethylene head stuck in the gluteus maximus. On the left we see the metal head articulating directly in the cup.

revision was decided which confirmed the presence of the mobile polyethylene in the gluteal muscle masses intraoperatively (Figure 11).

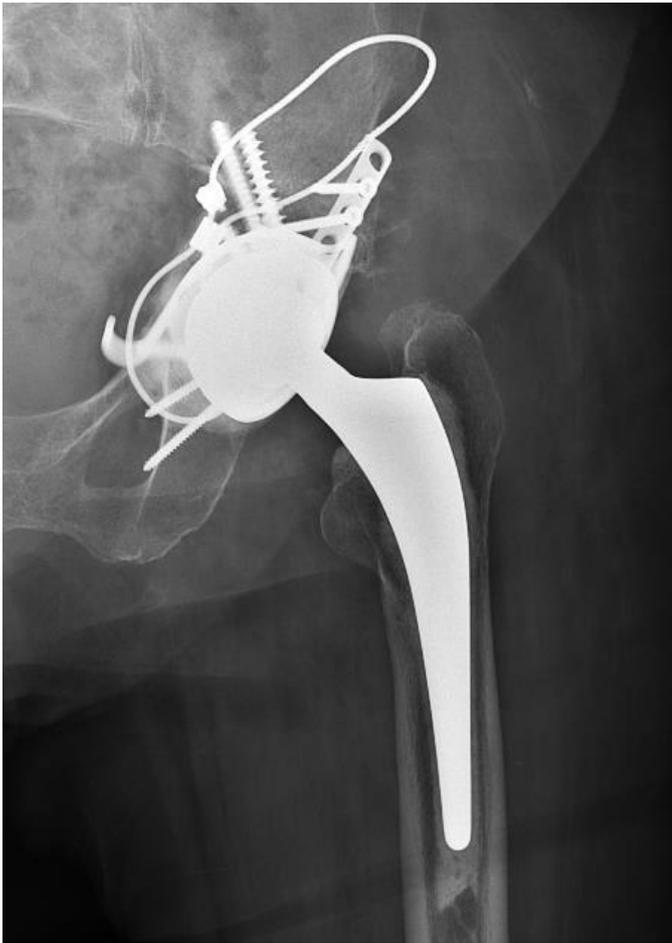
Figure 12 (left): 78-year-old female after revision surgery for intra-prosthetic dislocation.

Technique: plain anteroposterior hip radiograph.

Findings: post-operative picture showing implant in good place with revision cup implant of the hip prosthesis with reorientation of a new acetabular cup with good outcome.

The surgical revision involved changing and reorienting the acetabular component with a new dual mobility cup (Figure 12, 13). The 3-year follow-up was satisfactory with resumption of the walk in complete load without technical assistance, without new episode of dislocation and with a Harris score of 82 out of 100.

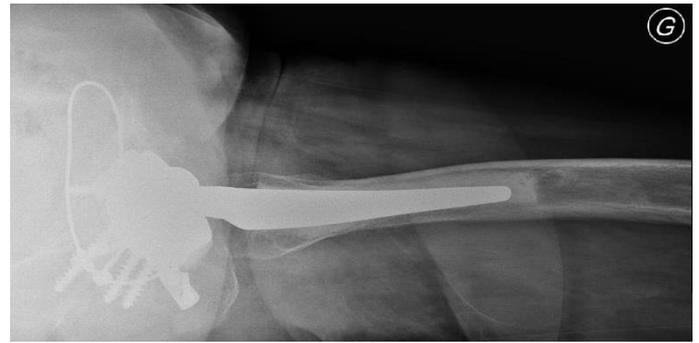
Figure 13: 78-year-old female after revision surgery for intra-prosthetic dislocation.

Technique: plain axial hip radiograph.

Findings: post-operative picture showing implant in good place with revision cup implant of the hip prosthesis with reorientation of a new acetabular cup with good outcome.

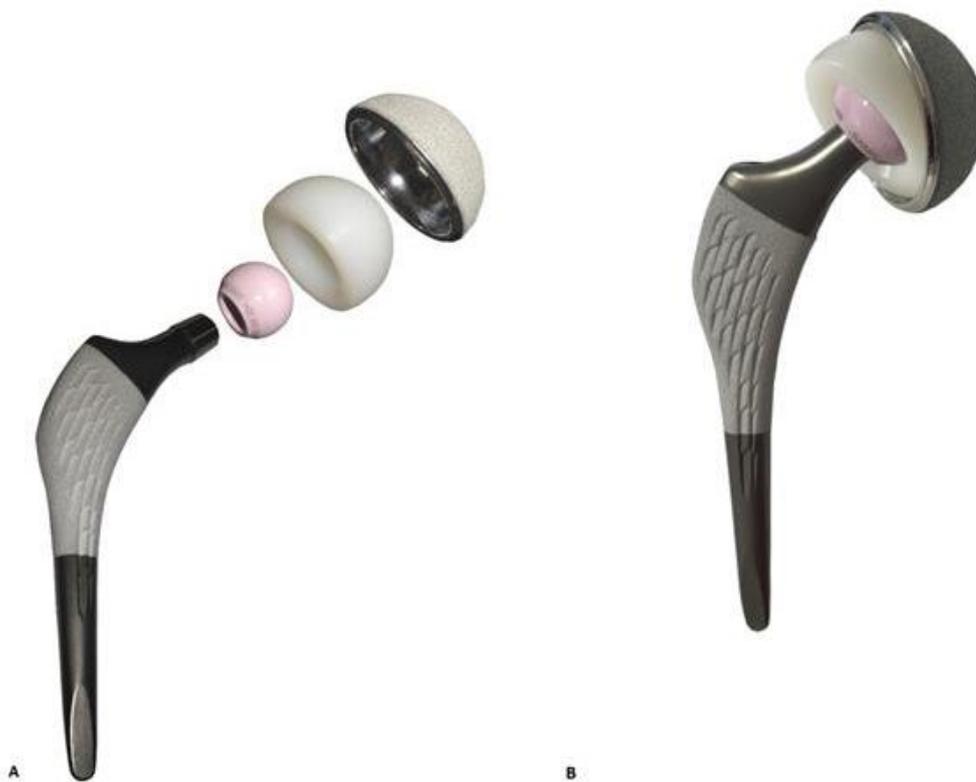
Figure 14:

(A) The various components of dual mobility implant (from left to right: stem - head - mobile polyethylene insert- cup)

(B) The implant assembled.

The concept of dual mobility consists of the interposition of a mobile polyethylene insert between the prosthetic head and the external metal cup (Figure 14) in order to increase the effective diameter of the prosthetic head. In comparison, in standard hip prosthesis, the polyethylene insert is fixed in the metal cup. Dislocation is still possible between the mobile insert and the metal cup, especially in case of abductor deficiency [4,5]. During a dislocation of dual mobility prosthesis, an attempt to reduce the dislocation by external maneuver is justified. The large volume of the insert can make this maneuver difficult and justifies a reduction under anesthesia.

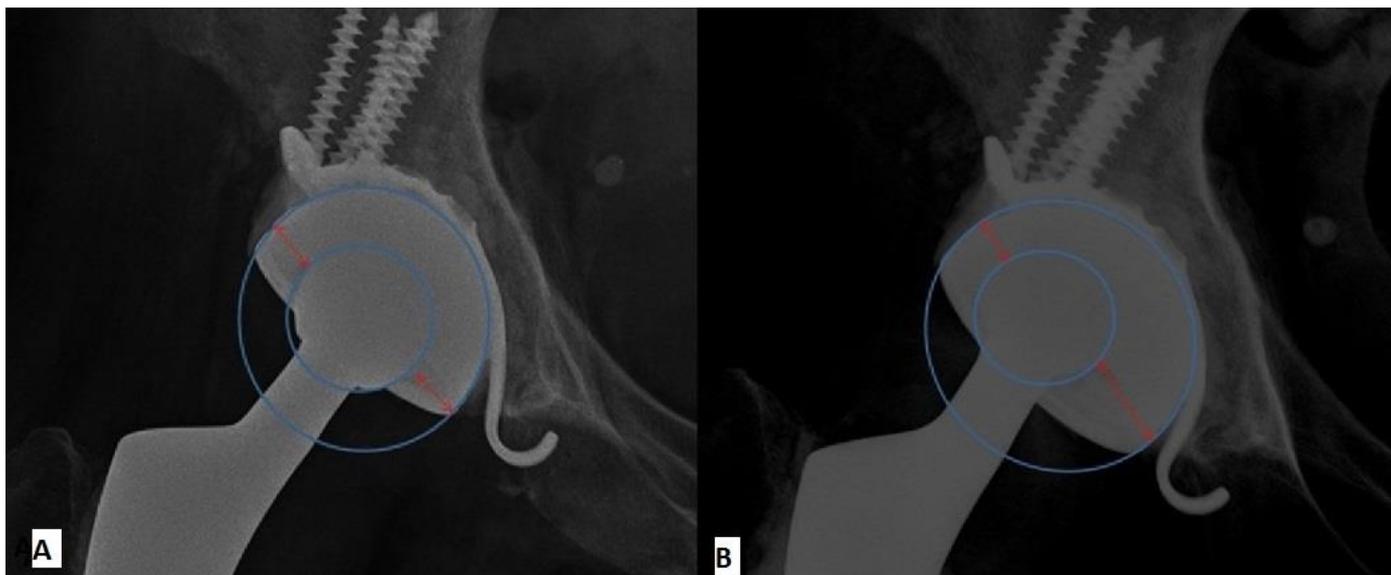
Figure 15:

(A) The various components of dual mobility implant on x-ray in good place. The head is in good place, on the center of the cup
 (B) Dual mobility implant on x-ray with intra-prosthetic dislocation after reduction maneuver, there is radiological eccentricity of the head in the cup, with direct contact between the two pieces because mobile polyethylene insert hooked on the rim of the cup.

On X-ray, after reduction maneuver, the head is in the center of acetabulum. At the opposite, with IPD after reduction maneuver, there is radiological eccentricity of the head in the cup, with direct contact between the two pieces (Figure 15).
